Winfield Locks

Failed Embedded Miter Gate Anchorage

Feb 2015

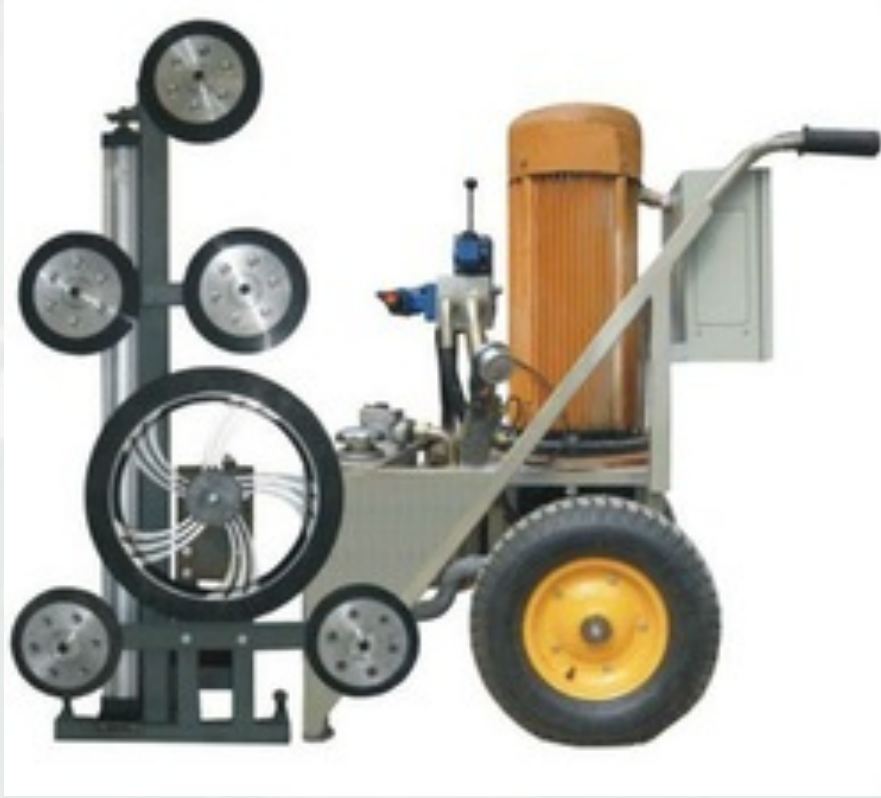
- May 2014 LRL fleet crew removed concrete to expose the top of the embedded anchorage.

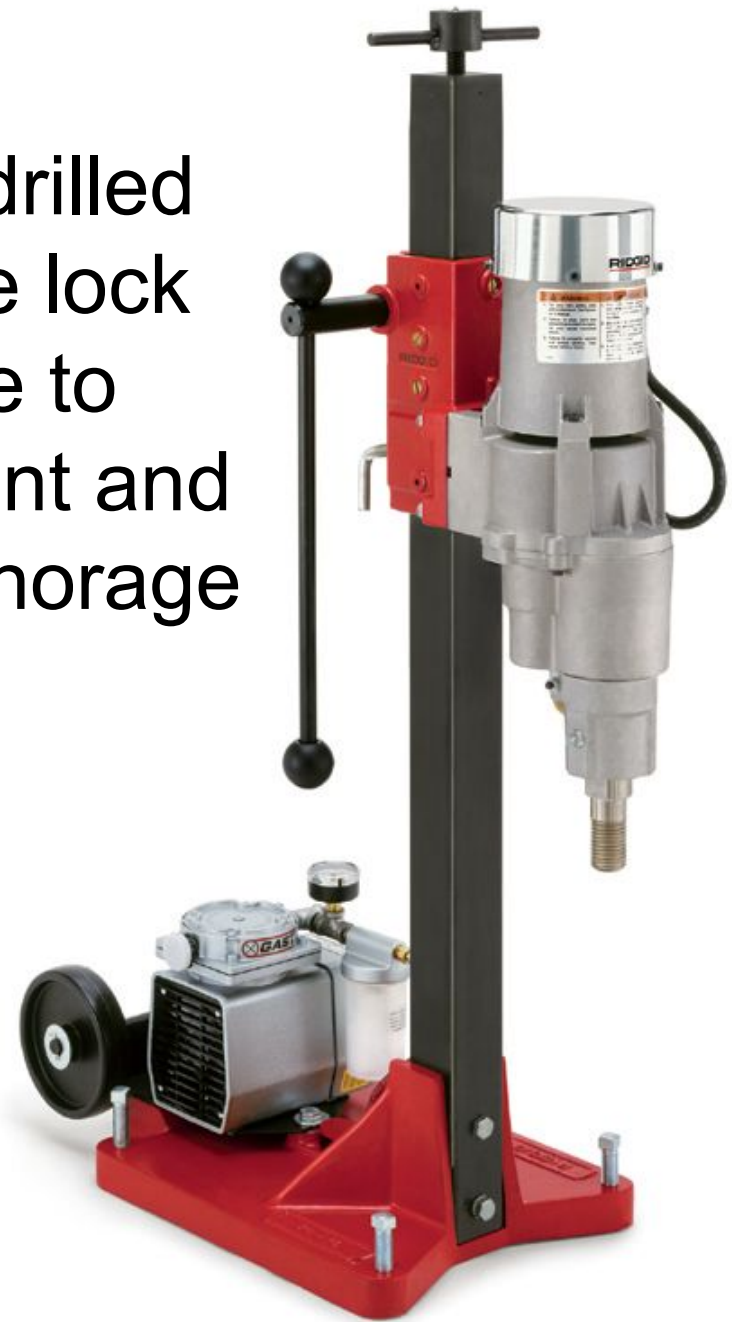
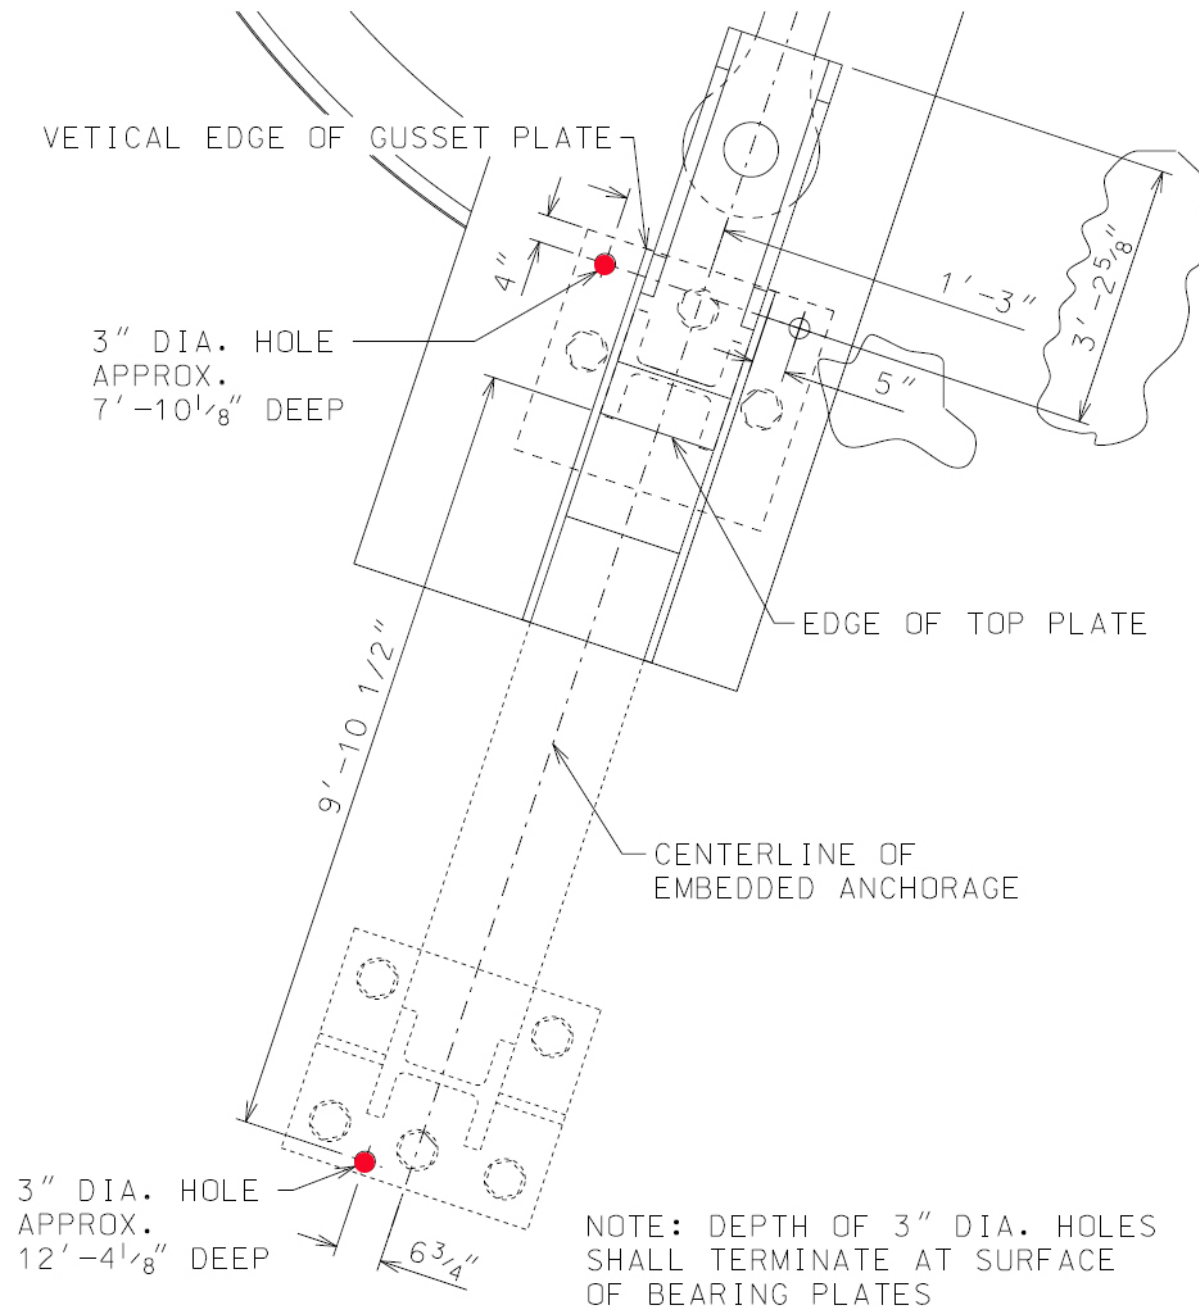
- June 2014 – a contractor drilled holes vertically through the lock wall to the anchorage base to measure movement on front and rear of the embedded anchorage

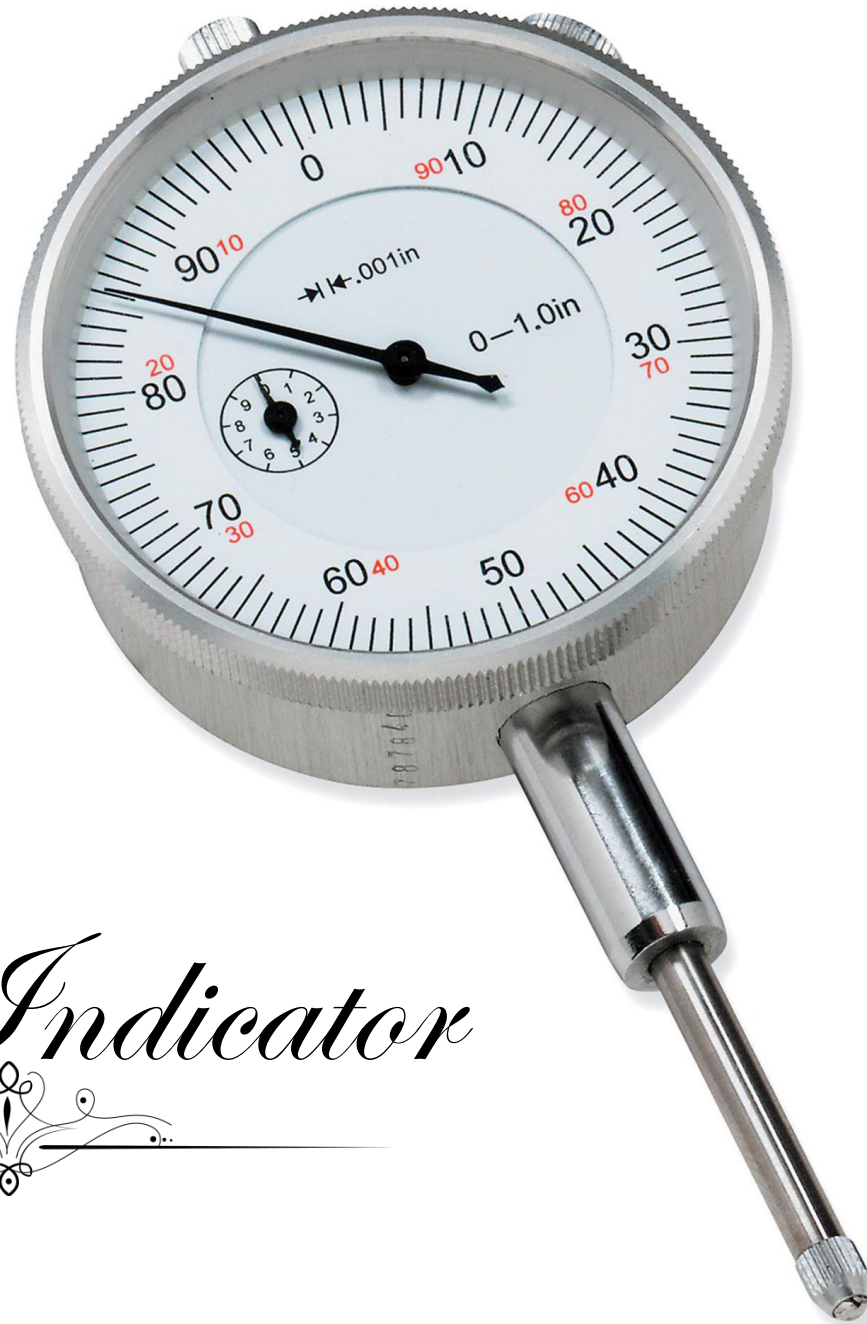
Dial Indicator

Front of
Anchorage
movement was
minimal- less
than 1/16"

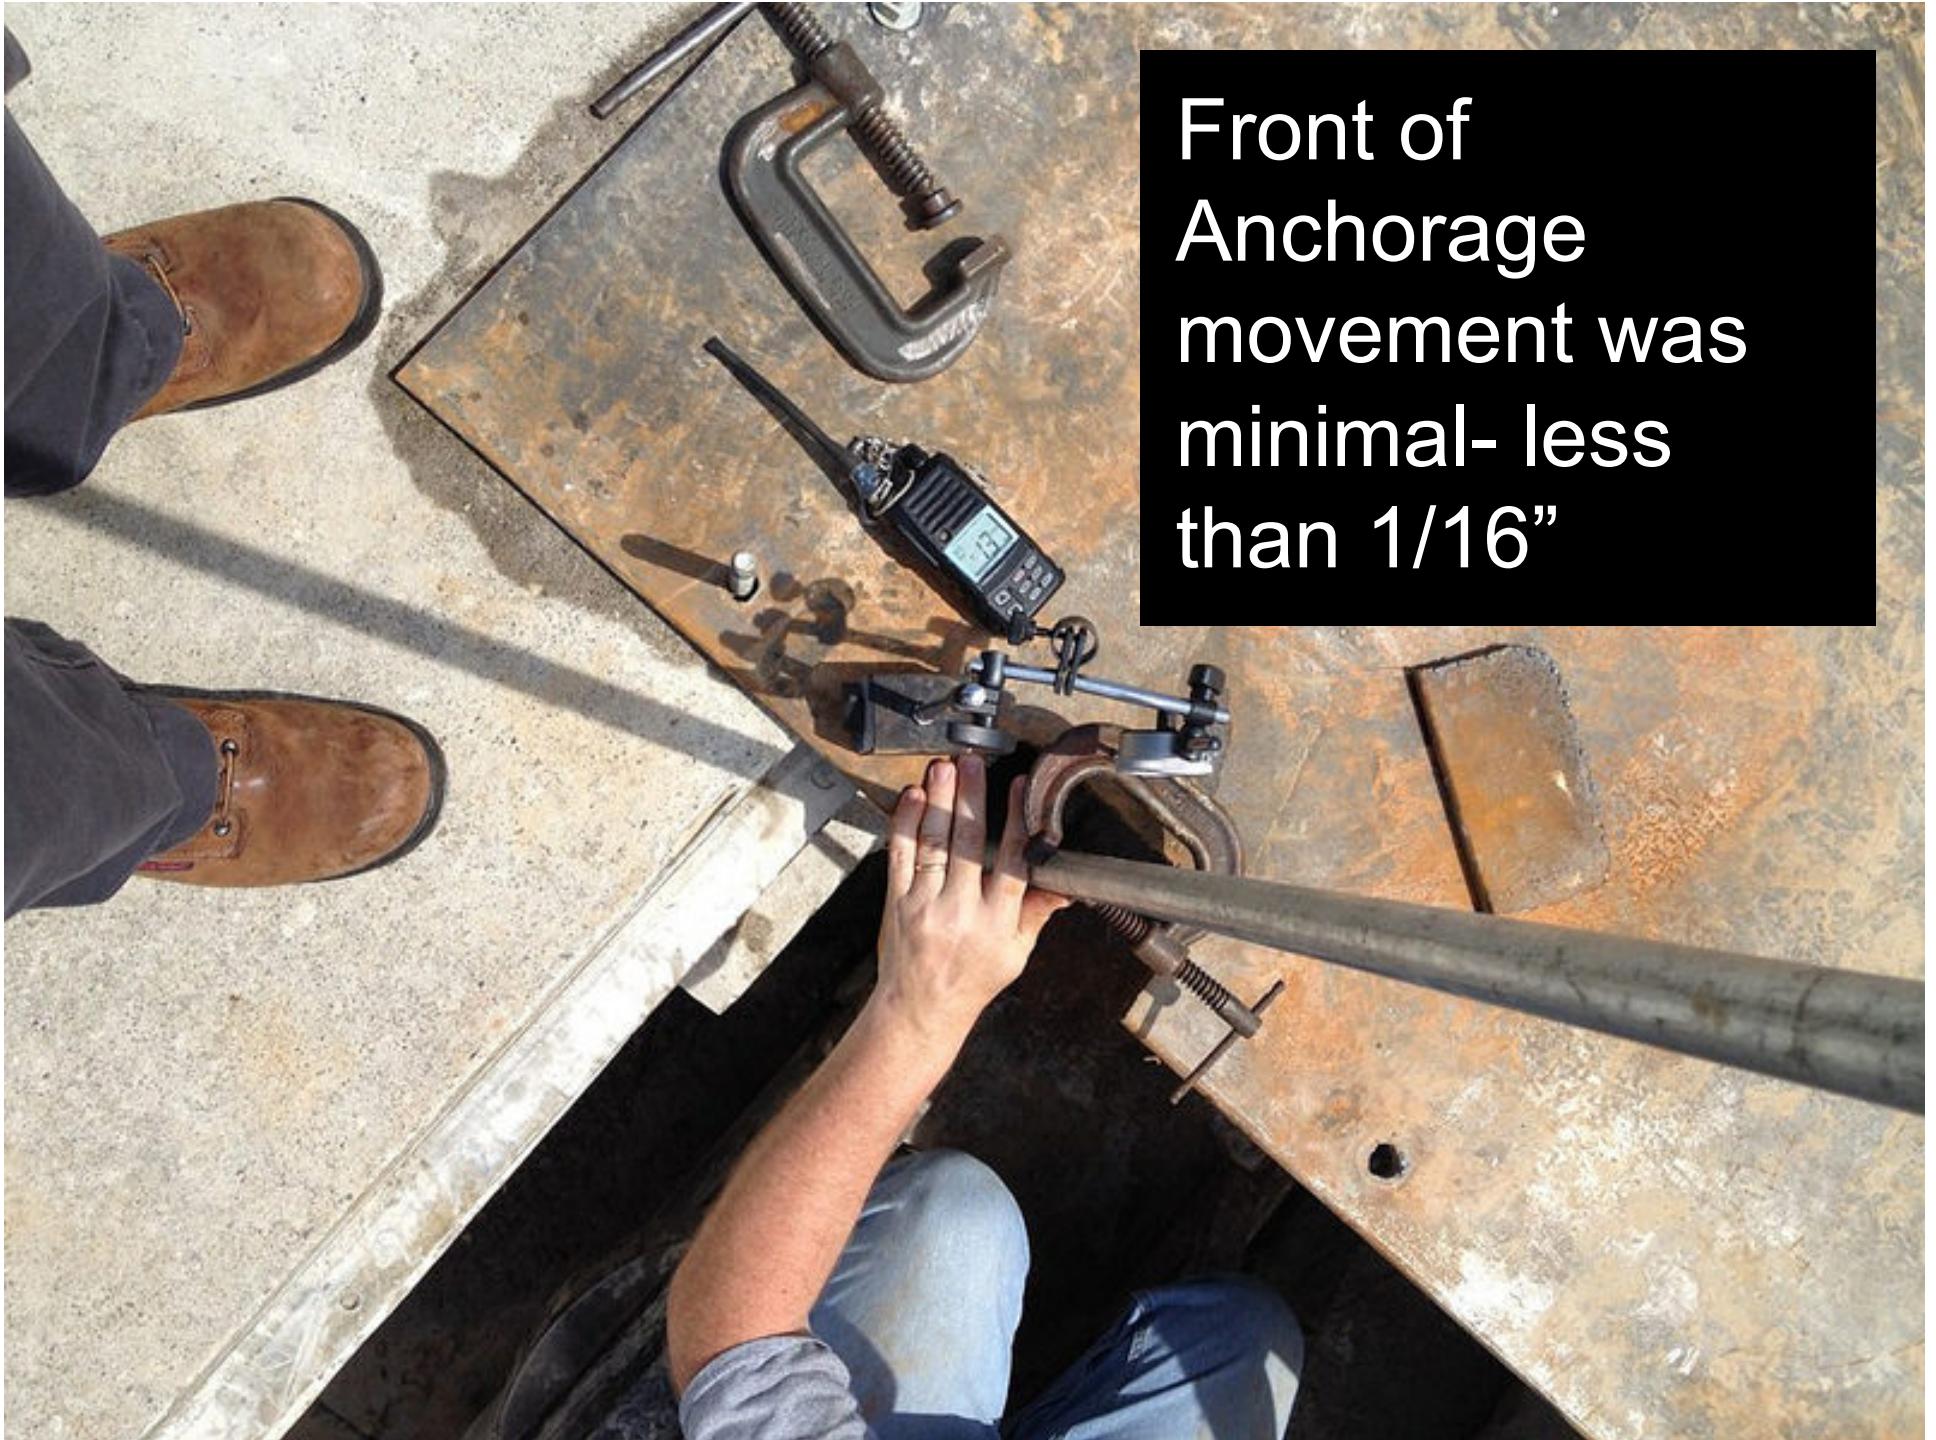
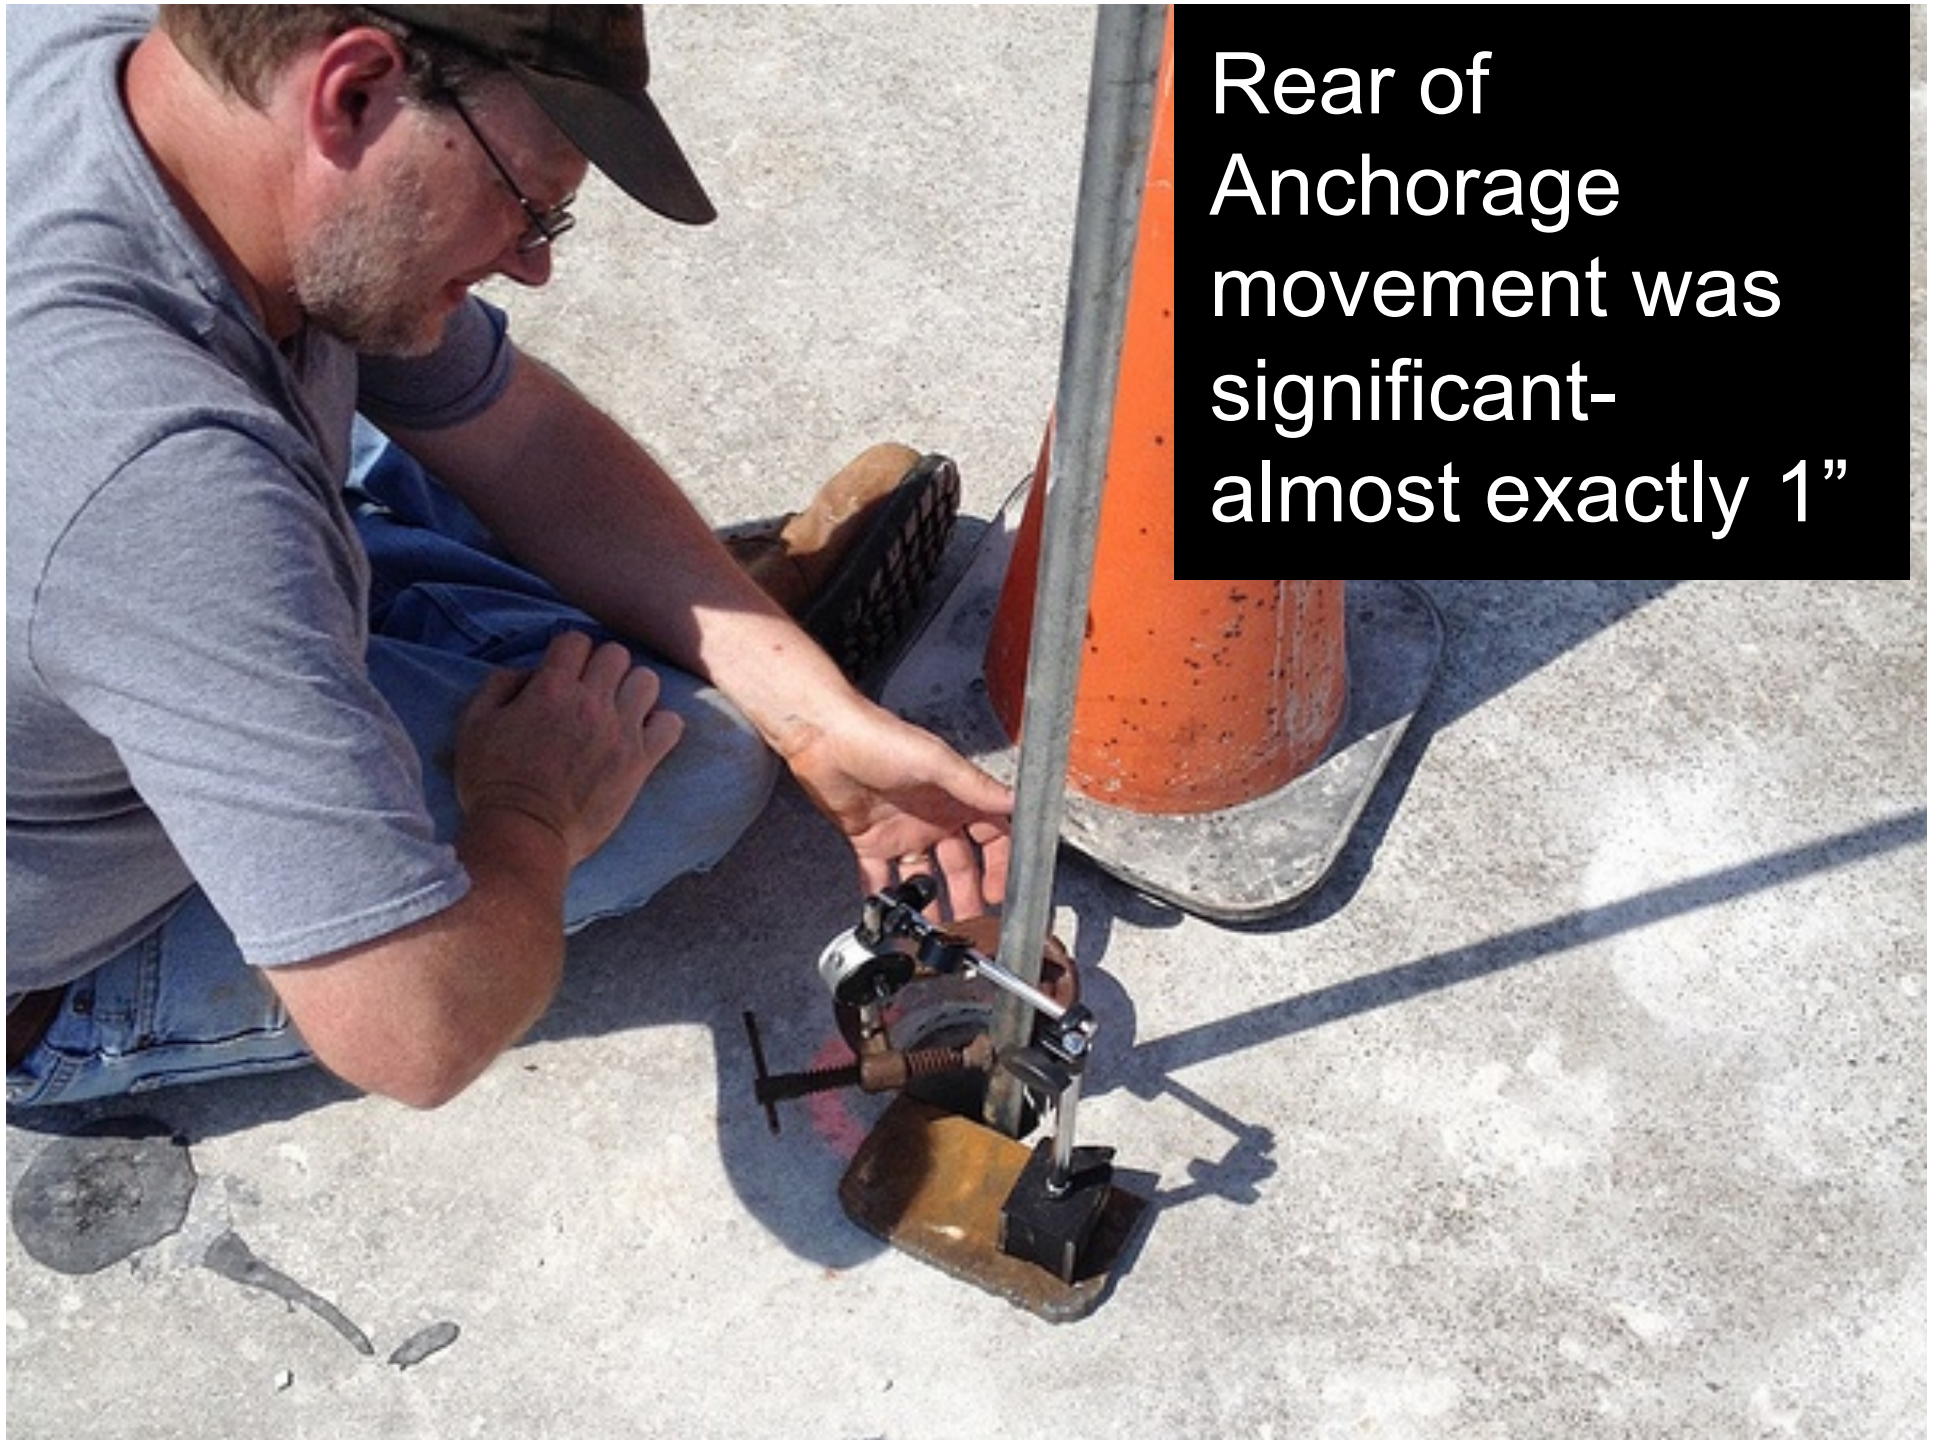
Rear of
Anchorage
movement was
significant-
almost exactly 1"
